ELLIS ISLAND
STATUE OF LIBERTY NATIONAL MONUMENT
EXISTING CONDITION SURVEY
UNITS 2, 3 AND 4

Volume 4
Appendix A
Part Two

Beyer Blinder Belle/
Anderson Nottter Finegold

U.S. Department of the Interior / National Park Service

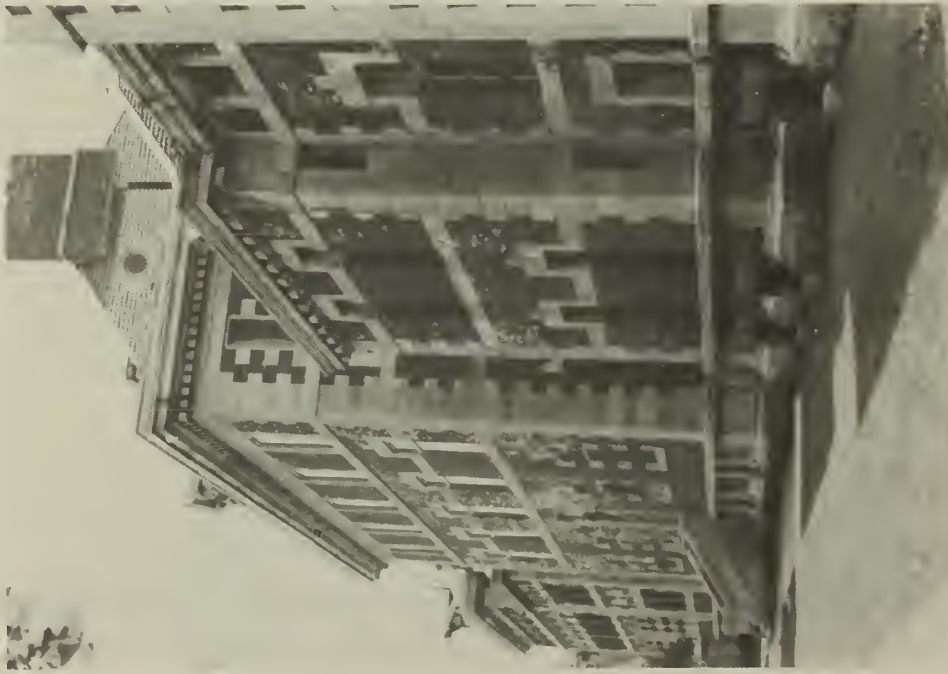
CONSTRUCTION DATE: 1907		SURVEY DATE:		Administration Building		
DESCRIPTION:	3 1/2 story with recessed connecting bays. Steel frame with structural tile infill on brick bearing walls and interior steel columns. Brick clad with granite base. Limestone quoins, sill and lintel coursing, window and door trim. Wood sash covered by plexiglass panels. Wood doors. Granite stairs with limestone balustrades. Clay tile hip roof with copper ridge, terra cotta cornice, chimney coping, copper cheneau and brick, terra cotta and copper dormers.					
	MATERIALS:	CONDITIONS:				
FACADE FOUNDATION/ BASE:	Brick. Granite.	Good condition. Random mortar deterioration. Efflorescence: all elevations. Severe green biological growth: west connector, north elevation.				
TRIM:	Limestone. Terra cotta.	General weathering. Random iron staining. Carbon soot, green biological and copper staining. General weathering. Some areas of surface cracking and crazing. Carbon soot deposits: protected areas.

North elevation, view east.

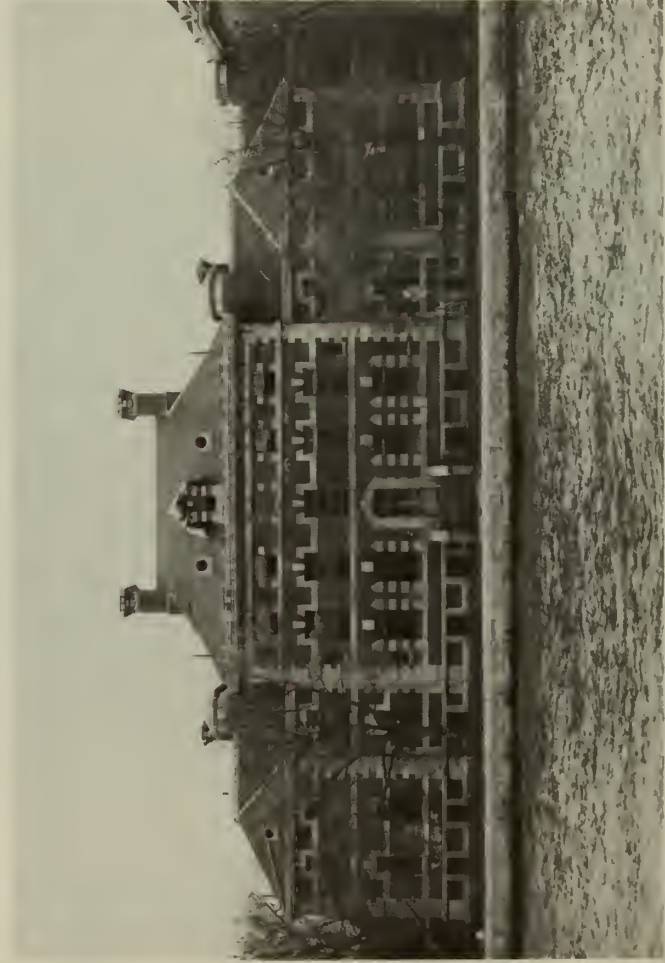
Granite.		
TRIM:	Limestone.	General weathering. Random iron staining. Copper staining: window sills below flyscreens.	
	Terra cotta.	Chipping, breakage and loss: cornice block. Displacement: northeast corner, east elevation. Severe displacement, spalling and loss: south elevation verandahs.	
	Concrete parging.	Poor condition: verandah balustrades; rust staining. spalling, and loss. Surface cracking, random loss: stair parging. (CONTINUED ON BACK)	
ROOF:	Clay tile.	Frequent displacement and loss.	
	Copper.	Tearing and loss of valley and ridge flashing. North elevation center dormer: damaged. South elevation dormer: loss of dormer.	
	Tarred surface.	Areas of erosion and loss.	
WINDOW S/ DOORS:	Wood.	Flaking loss of painted finish. General surface weathering. Wood rot and random loss. Severe deterioration: east elevation door.	
	Metal/copper sash.	Random breakage and loss.	
	Glass.		
MISC.:	Wood frame sheds: south elevations.	Deteriorated.

SUMMARY:	CONDITION:	GOOD FAIR POOR DESTROYED XXX XXX (south elevation verandahs)

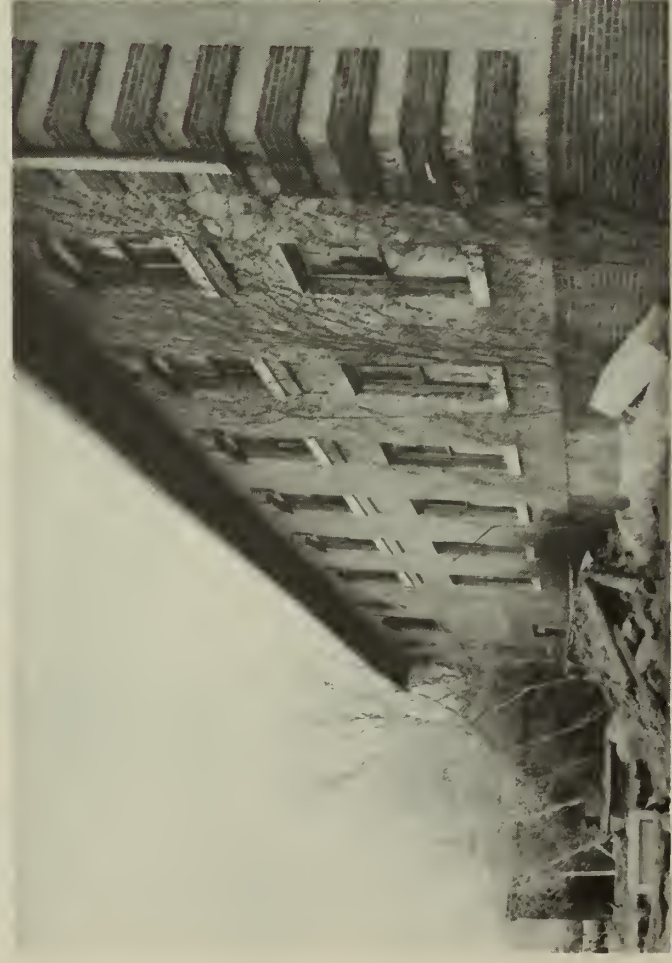
West elevation, view north.

South elevation, view east.

WINDOWS/ DOORS:	Wood sash.	Deteriorated finish, weathered sash. Some opaque glass infill, inconsistent with window glass type.	
MISC.:			
SUMMARY:	CONDITION:	GOOD XXX FAIR POOR DESTROYED

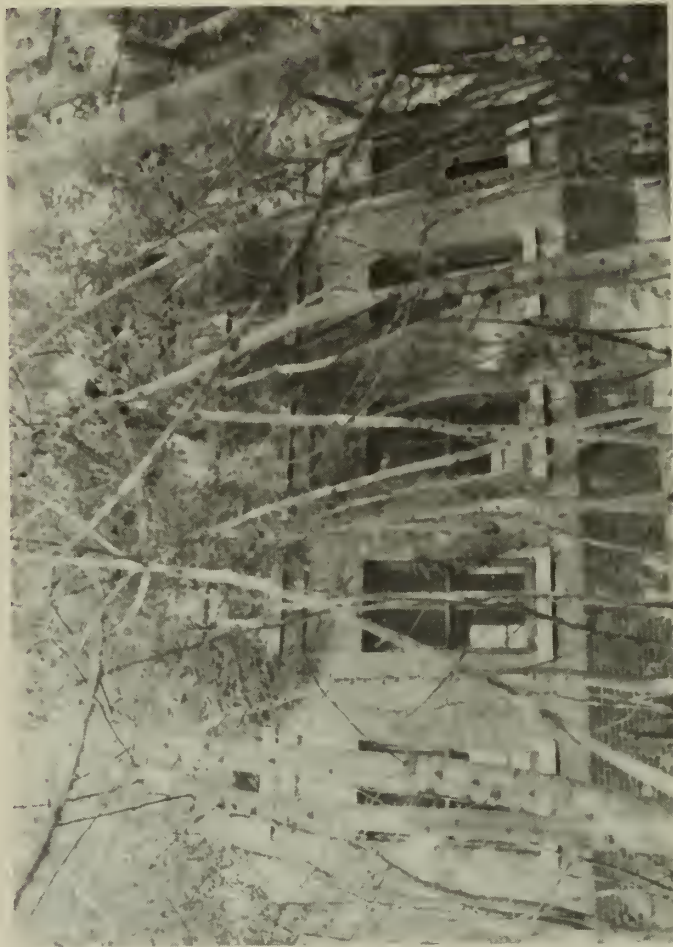
CONSTRUCTION DATE: 1908		SURVEY DATE: 5/1/86	
DESCRIPTION:	2 stories. Concrete joists and steel beams on bearing walls; wood roof framing. Pebble dash stucco facade, brick base, granite sill. Brick quoins, window springers, keystones. Limestone window lintels, sills. Clay tile hip roof. Wood eaves. Copper gutters. North elevation connected to corridor 9D.		
	MATERIALS:	CONDITIONS:	
FACADE FOUNDATION/ BASE:	Pebble dash stucco.	Some cracking, often from corner of window sill. Patchy loss of aggregate: west elevation, south end. Carbon soot staining at juncture with corridor. 9D and under eaves.	
	Brick.	Random mortar loss. Some damage to brick in area of pipe protruding from interior of building: north end, east elevation. Cracking and damaged brick: west end of south elevation.	
	Granite. Brick. Limestone.	Green biological staining. Efflorescence.	
TRIM:			
ROOF:	Clay tile. Wood eave. Copper gutters.	Weathered surfaces.

South elevation, view north.

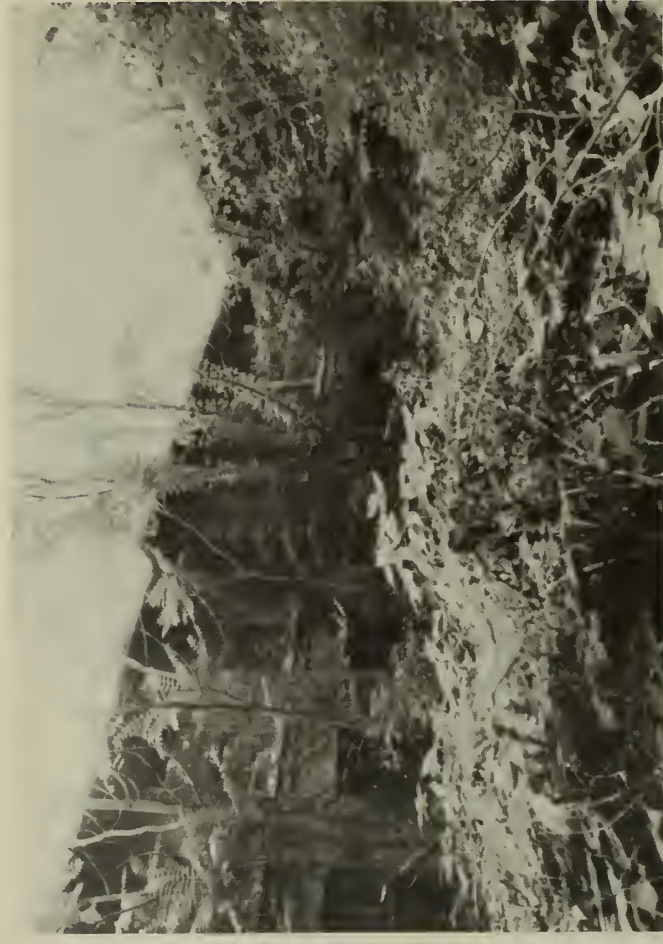
MISC.:	Metal stair with wire grille enclosure: north elevation. Concrete stair: north elevation.	Rusting. Cracking.	
SUMMARY:	CONDITION:	GOOD FAIR POOR DESTROYED

East elevation, view west.

West elevation, view southeast.

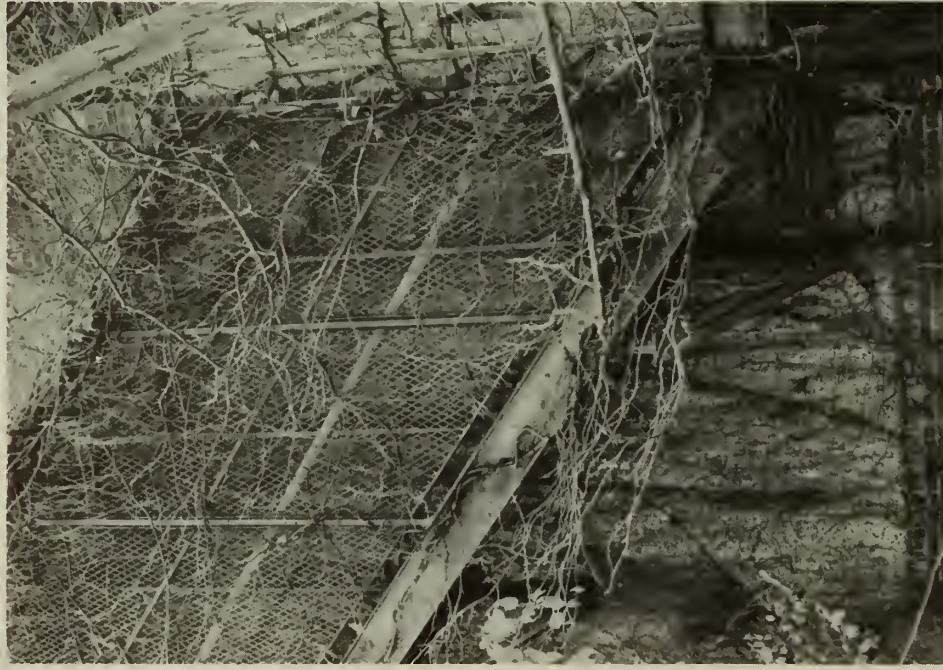
WINDOWS/ DOORS:	Steel sash. Glass.	Surface rusting. Random broken glass. Installation of metal grilles: second floor windows, west and south elevations.	
MISC.:	Metal stair with wire enclosure: to second level, north elevation.	Rusting. Detachment of sections of stair enclosure.	
SUMMARY:	CONDITION:	GOOD FAIR POOR DESTROYED

North elevation, exterior stair.

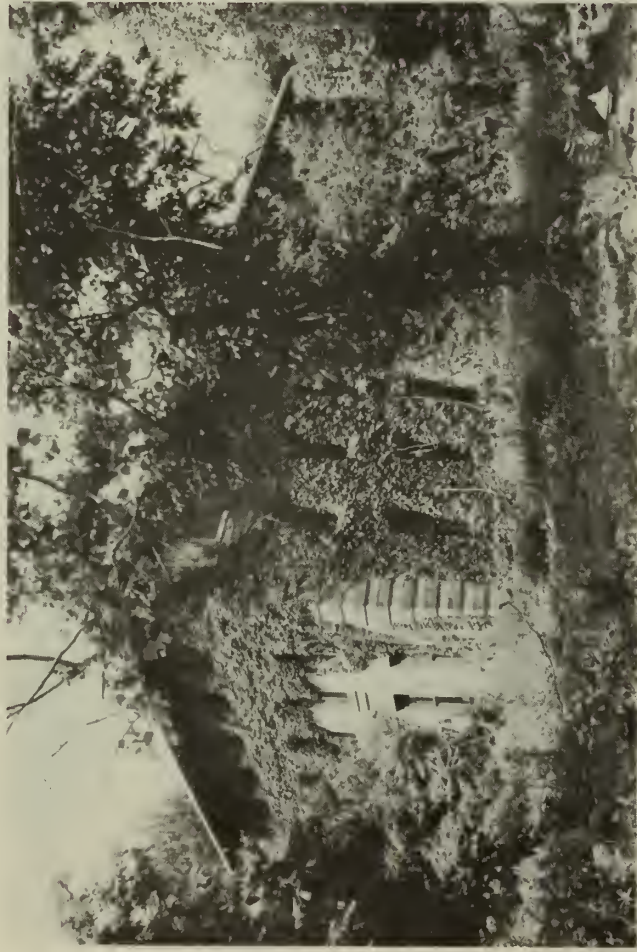
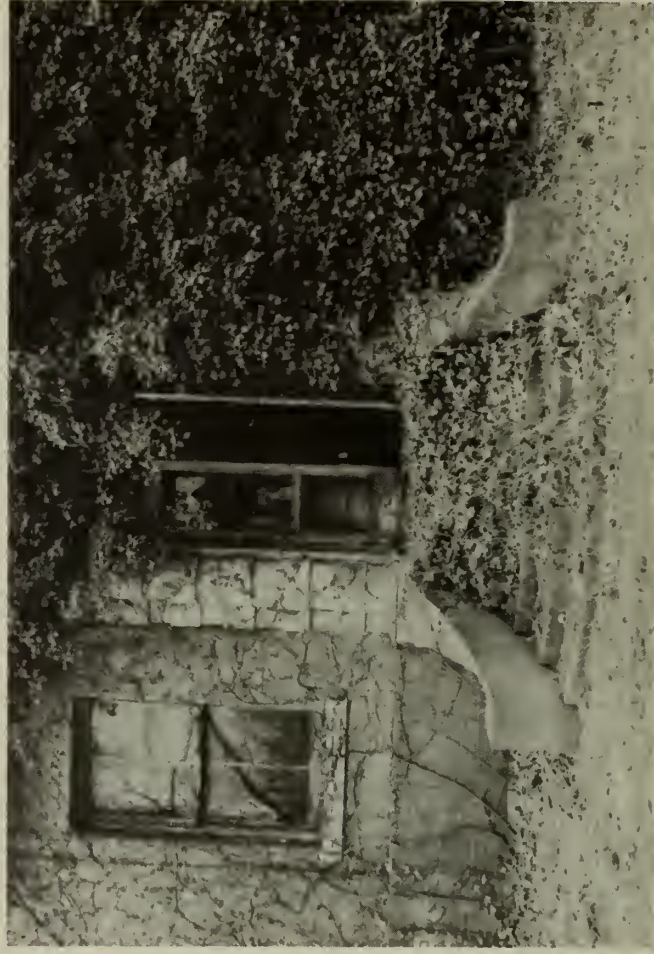
WINDOWS/ DOORS:	Wood. Glass. Iron balustrades: east and west elevations.	Weathered. Random broken panes. Some opaque glass replacement. Rusting of metal surfaces.		
MISC.:				
SUMMARY:	CONDITION:	GOOD FAIR POOR DESTROYED

North and east elevations, view
southwest.

North entrance.

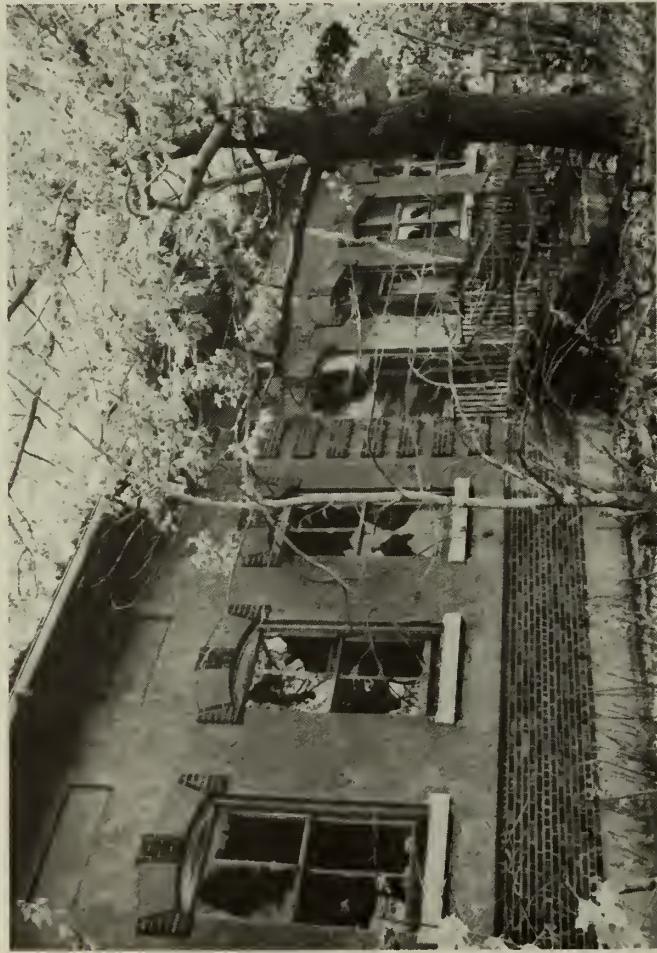
ROOF:	Clay tile. Wood. Copper. Dormers.	Weathering. Random loss of eave parts. Damage to eave horizontal boards: west end, central bay. Loss of downspouts.	
WINDOWS/ DOORS:	Wood. Glass.	Weathered wood sash. Random broken glass. Infill of second window from south end: west elevation.	
MISC.:	Iron vent door: south elevation. Granite stoop. Iron railings.	Rusting.	
SUMMARY:	CONDITION:	GOOD FAIR POOR DESTROYED

South elevation, view northeast.

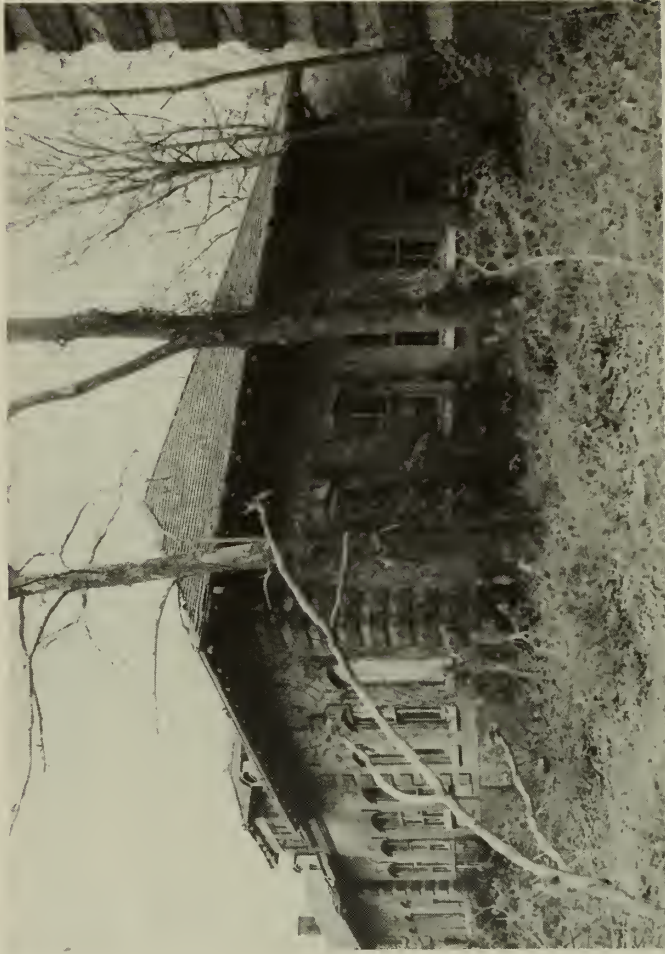
WINDOWS/ DOORS:	Wood. Wood door: east elevation.	Dormer windows: displacement of sash. Stucco infill: second window from north end: east elevation. Lifting of overpaint. Rusting of metal lintel.	
MISC.:	Granite stoop. Iron stair railings.	Lower concrete step: displaced. Rusting.	
SUMMARY:	CONDITION:	GOOD FAIR POOR DESTROYED

North elevation, view southwest.

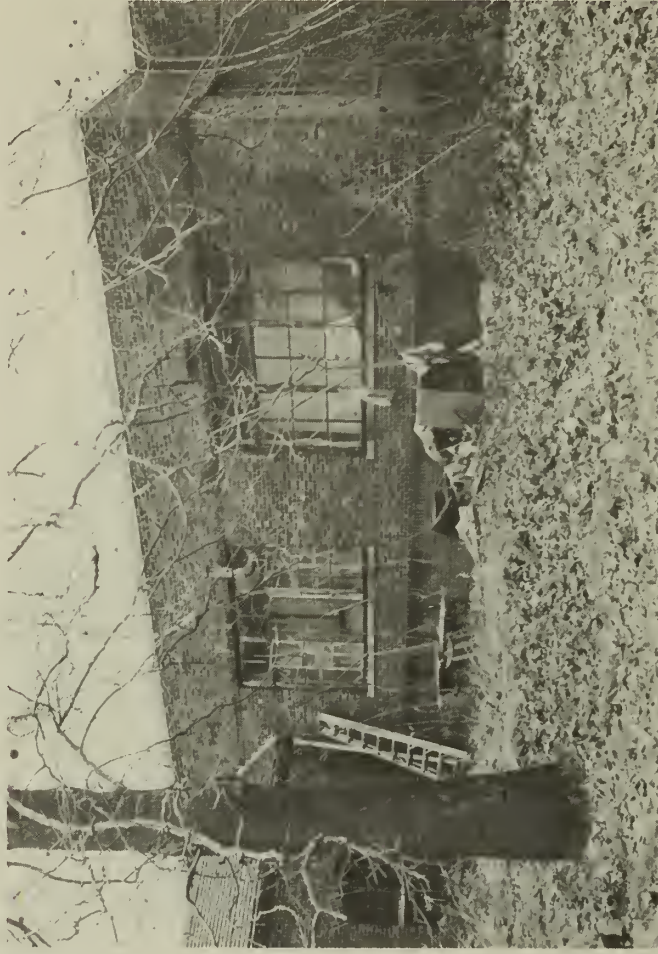
CONSTRUCTION DATE: 1935		SURVEY DATE: 1/17/85	
DESCRIPTION:	1 story masonry bearing wall with roof and floor of concrete joists and beams. Brick clad with terra cotta window sills and roof coping faced with copper flashing. Steel sash. Hollow metal and wood doors. Flat wood roof surfaced with tar containing small aggregate. Metal roof ventilators.		
	MATERIALS:	CONDITIONS:	
FACADE FOUNDATION/ BASE:	Brick.	General flaking loss. Cracking: east elevation. Random mortar deterioration and separation from brick surfaces. Efflorescence: all elevations.	
TRIM:	Terra cotta. Copper.	General weathering: Random chipping. Iron staining: most sill surfaces. Carbon soot staining. Biological staining: window sills, most elevations.	
ROOF:	Tar/aggregate. Metal.	Fair condition. Bubbling along roofing felt seams. Water accumulation: southeast corner, south wing. Some damage and areas of loss.	
WINDOWS/ DOORS:	Steel. Glass. Hollow metal. Wood.	General surface pitting and rusting. General loss of painted finish. General cracking, breaking and loss of glass. Rusting resulting in some loss. Replacement. Severely deteriorated.

MISC.:	Metal and wood grilles.	Wood: some deterioration and loss.	
SUMMARY:	CONDITION:	GOOD FAIR POOR DESTROYED XXX

North elevation, view southwest.

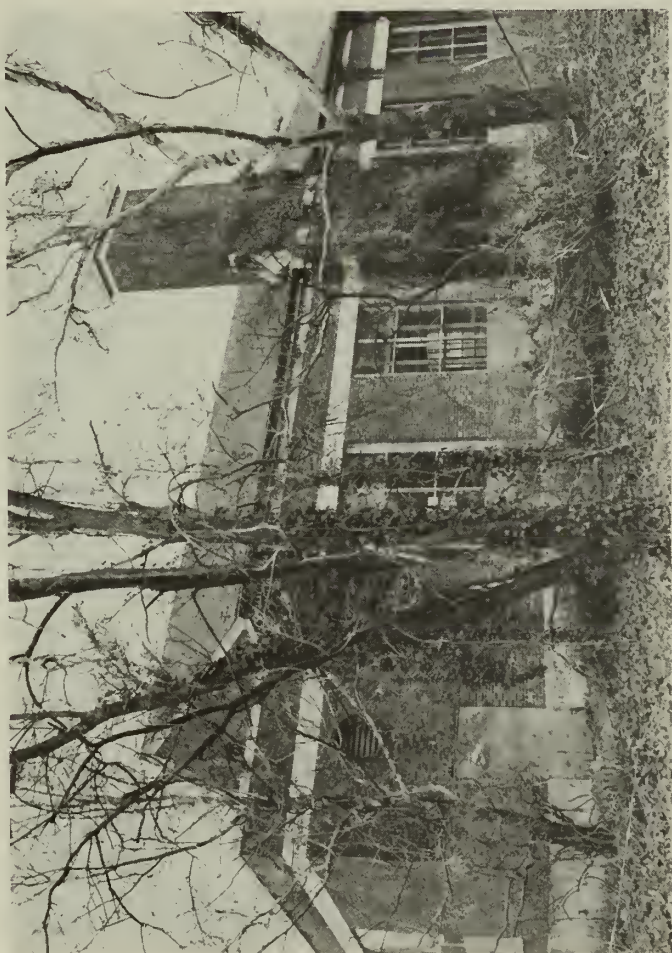
ROOF:	Clay tile. Roof felt/asphalt/ballast. Copper.	Intermittant loss of tile with 4 foot wide swath of loss: east elevation. Gutters and downspouts: clogging, damage and loss of parts.	
WINDOWS/ DOORS:	Steel/metal. Wood. Glass.	Surface corrosion. Plexiglass and wood window infill.	
MISC.:			
SUMMARY:	CONDITION:	GOOD FAIR POOR DESTROYED

East elevation.

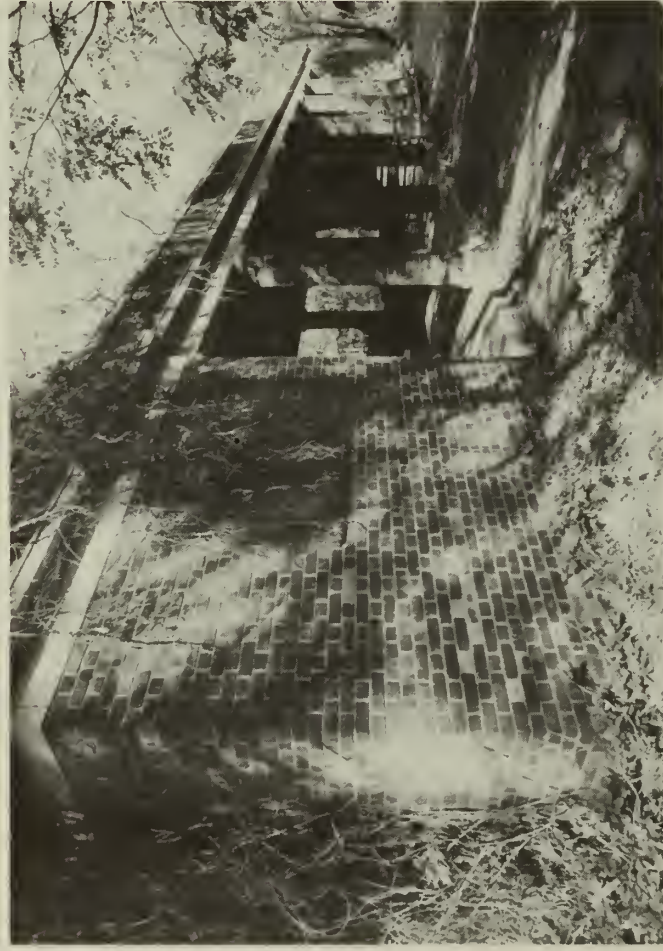
East elevation, view northwest.

DESCRIPTION:	1 story pavilion with central open double colonnade. Masonry load bearing walls with reinforced concrete slab floor on spread footings and piles. Brick clad with terra cotta trim. Steel sash. Wood and glass paneled doors to north and south rooms. Flat felt, asphalt and ballast roof.													
	MATERIALS:	CONDITIONS:												
FACADE FOUNDATION / BASE:	Brick	Areas of mortar loss: north and west elevations. Efflorescence: all elevations. Vine cover. Green biological staining: upper areas of west and north elevations.												
TRIM:	Terra cotta	General surface weathering, chipping, spalling and some breakage. Mortar disintegration. Carbon soot staining.												
ROOF:	Roof felt /asphalt/ballast													
WINDOWS/ DOORS:	Steel Wood Glass	General surface rusting. Some breakage of window glass: east facade.												
MISC.:														
SUMMARY:	CONDITION:
